ADF&G TECHNICAL DATA REPORT NO. 106  
(Limited Distribution)

## REVISED ANADROMOUS STREAM CATALOG OF SOUTHEASTERN ALASKA

District 106

North Prince of Wales Island

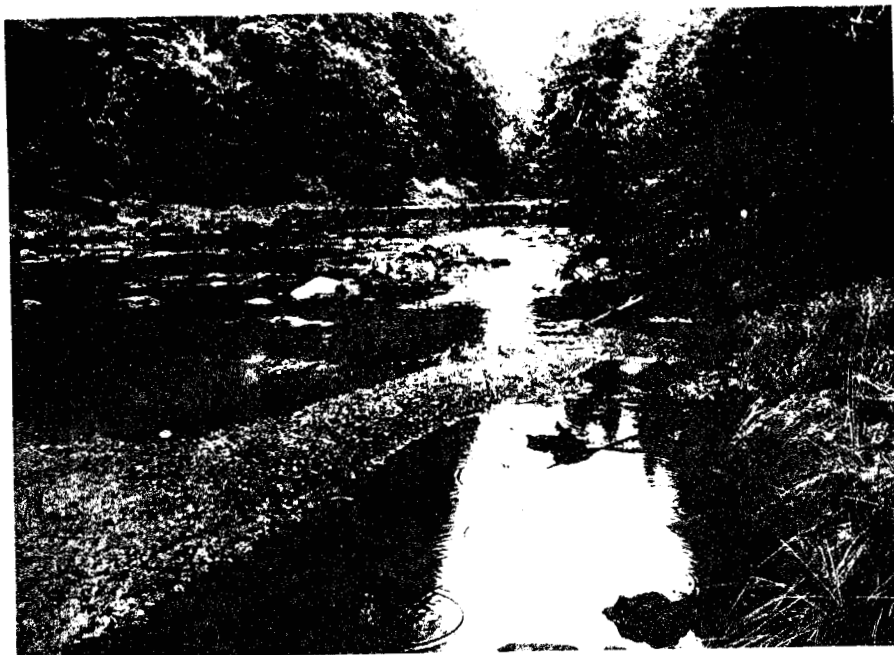
3. Section 2I: Wide channel with gravel and sand substrate interspersed by large boulders provides spotty ASA.

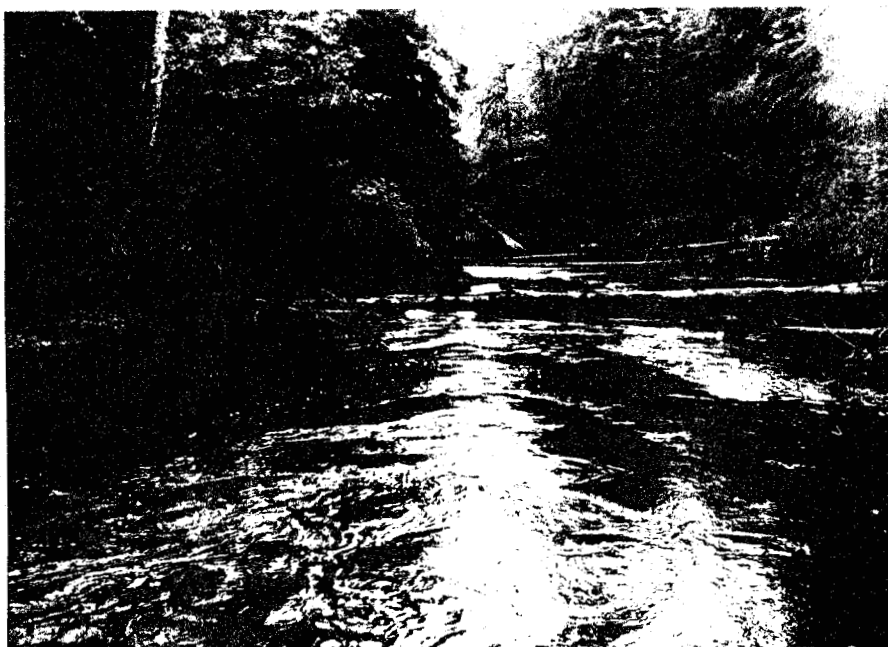
4. Section 5: Downstream view of several blowdown induced "holding" areas. Milling chum salmon and Dolly Varden were observed.

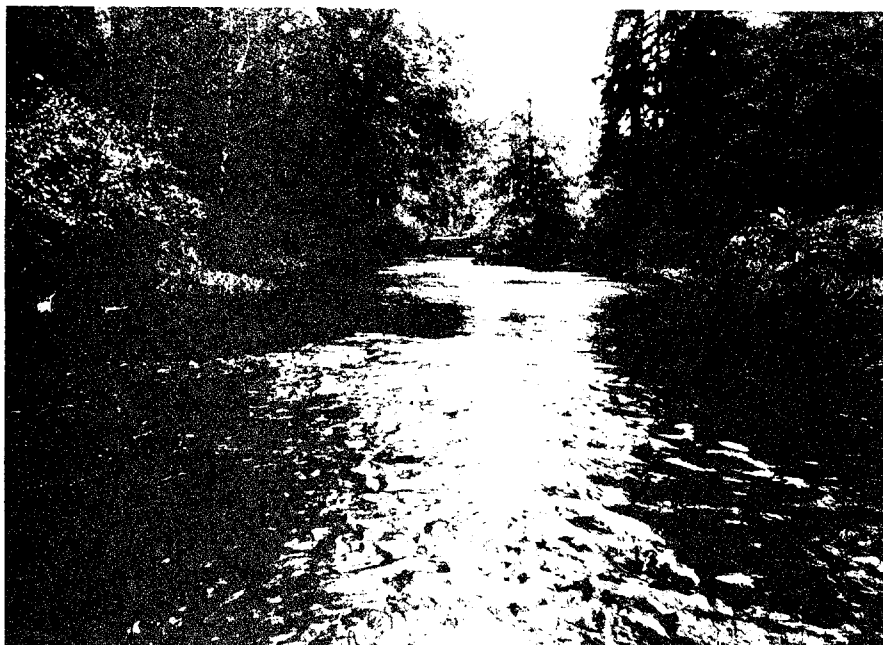
5. Section 6: Gravel riffles provide excellent spawning habitat. Spawning CT observed.

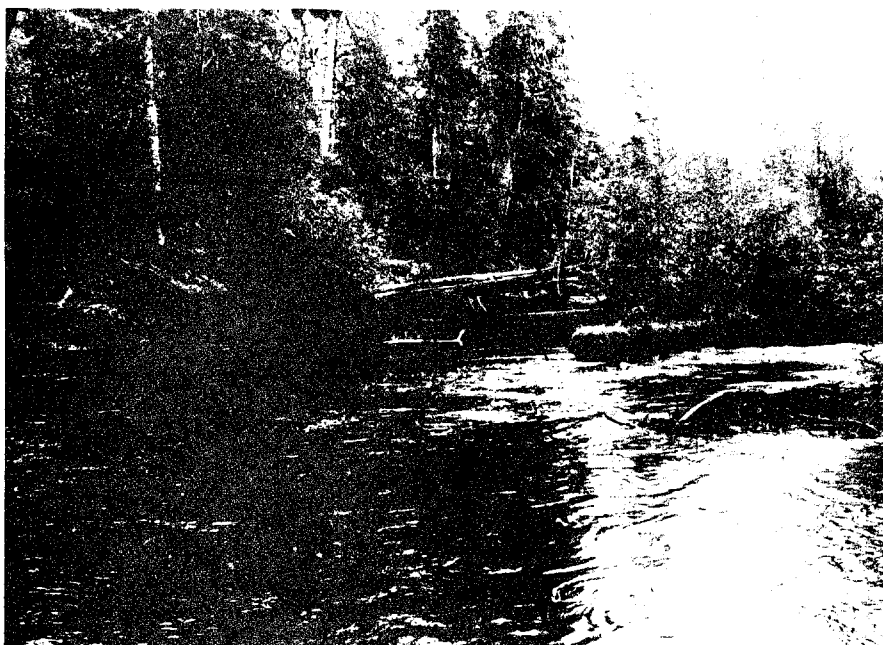
6. Section 7: "Passable" debris jam, 100 m below "East Fork" confluence. May warrant removal at later date.

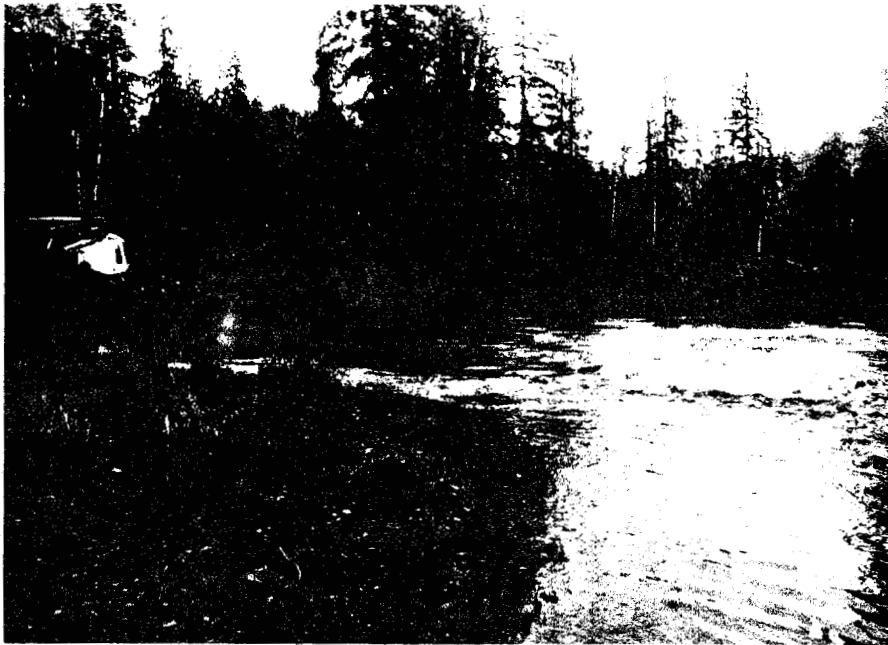
7. Section 8: "East Fork" of Red Creek converges with the main stem via the left bank. Cutthroat trout, sockeye and chum salmon were observed "milling" at mouth.

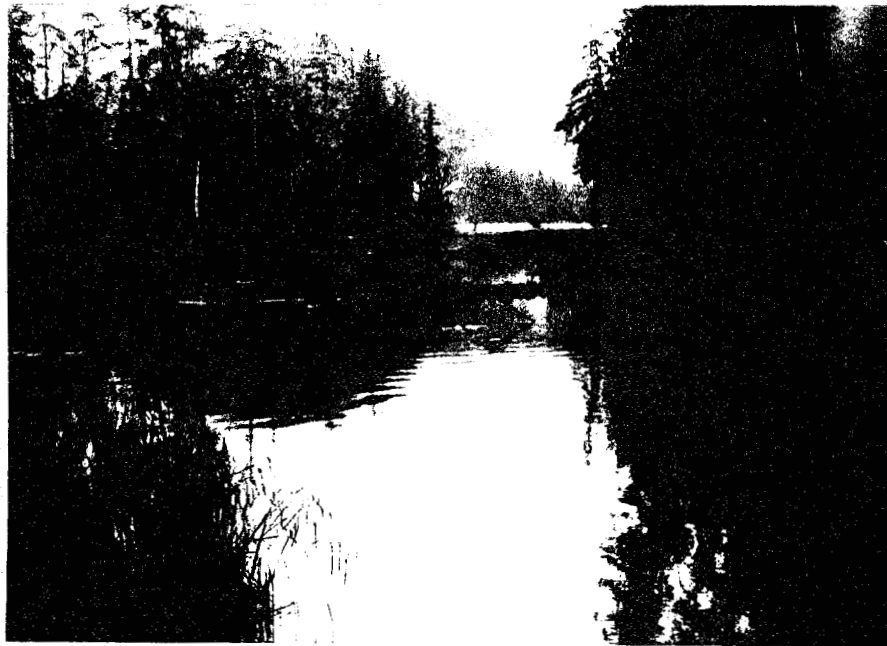
8. Section 9 & 10: Slough-like channel extends to lake proper. Copious aquatic and overhanging vegetation provides excellent rearing cover. No ASA observed.

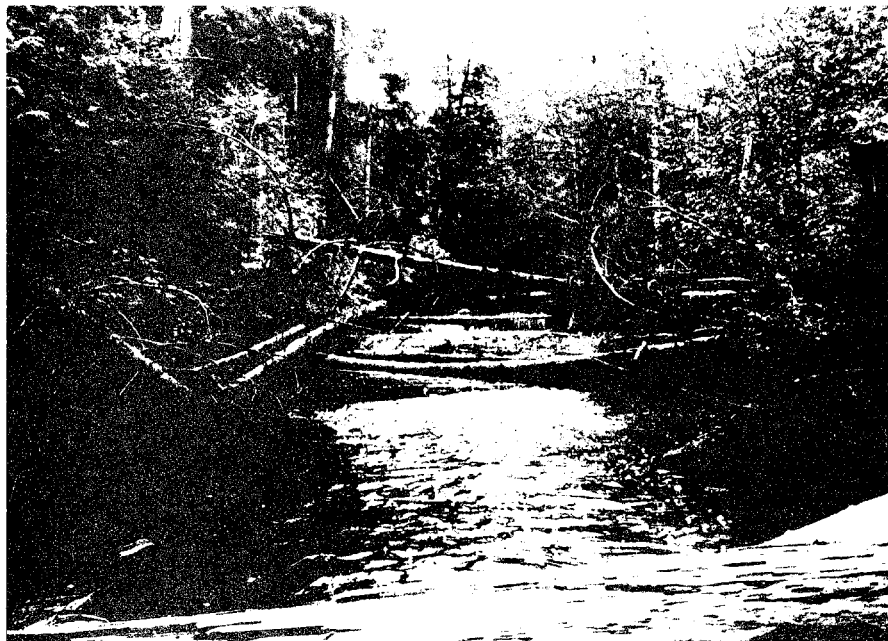
4. Section 13: Numerous side slope failures and heavy blowdown within notch, generates copious instream debris/jams.

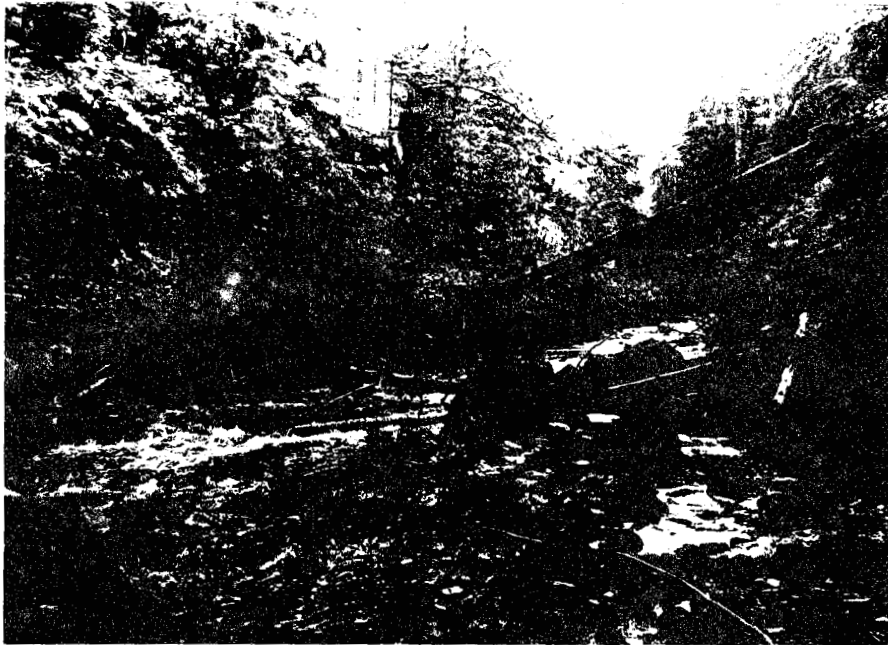
5. Section 18: Steep channel gradient and coarse substrate provide sporadic, marginal rearing and no ASA. Blowdown and side slope failures common.

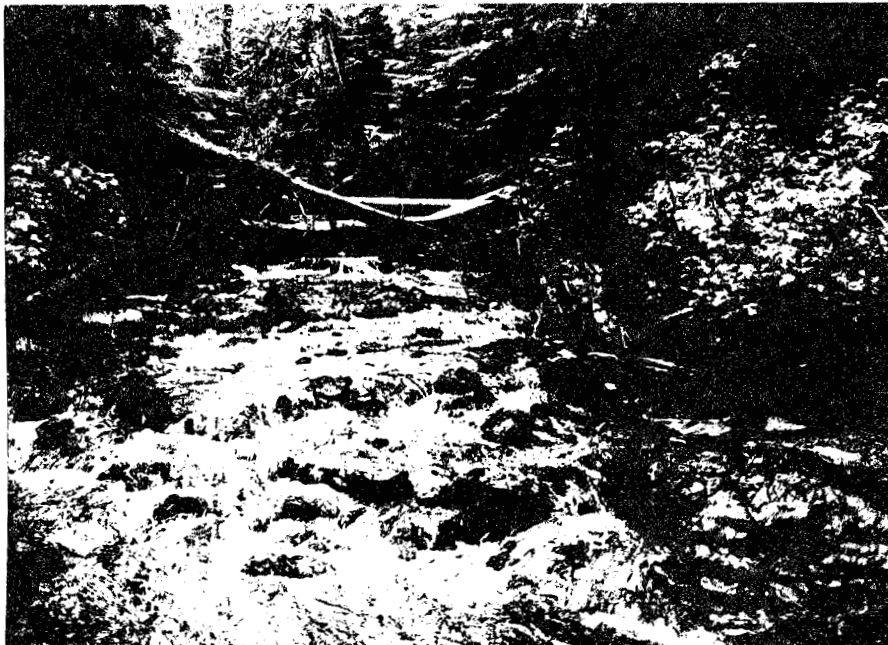
6. Section 25: Cobble/boulder V-notch continues. Numerous instream logs/stair step cascades. Rearing habitat extremely limited and no ASA observed. Blowdown and side slope instabilities common.

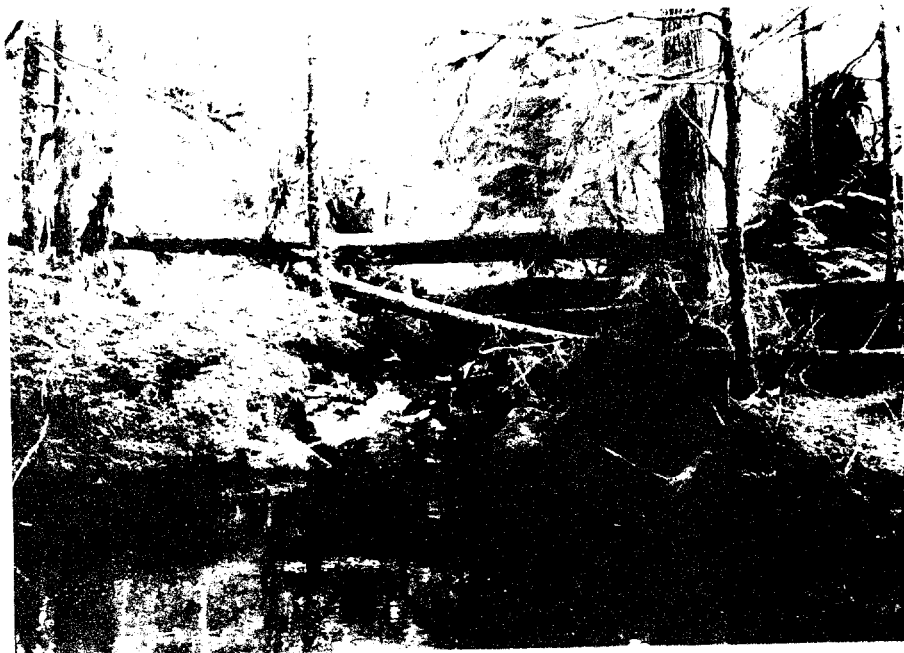
2. 2.0 m cascade over bedrock with debris jam at top  
of cascade. Section 2: 68 m.

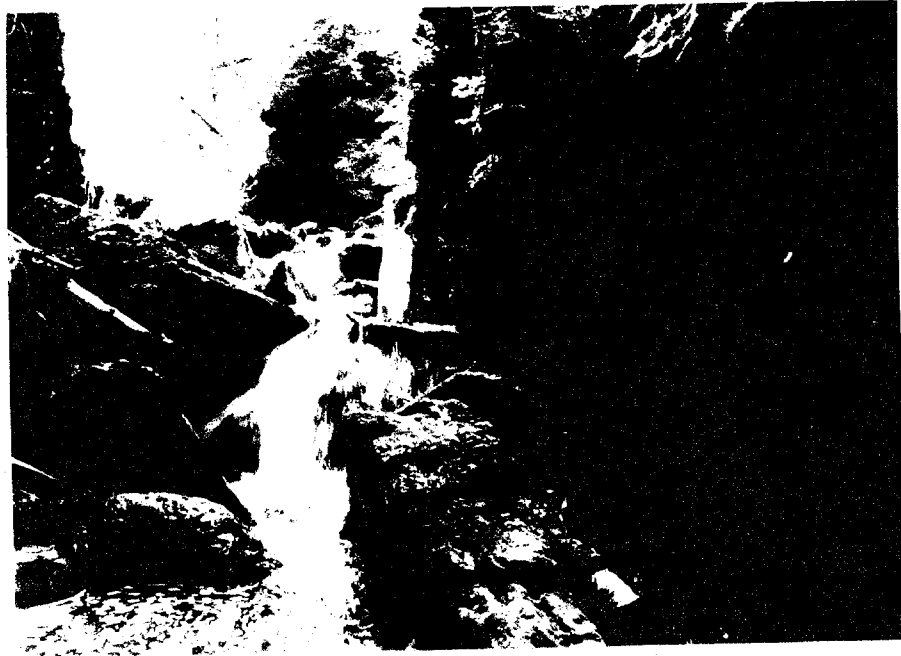
9. V-notch, cascade at end of Section 1: Tributary "C".
